ADAPTING TO CLIMATE CHANGE

ATLANTIC COASTAL TRAILS AND BOARDWALKS & CLIMATE CHANGE

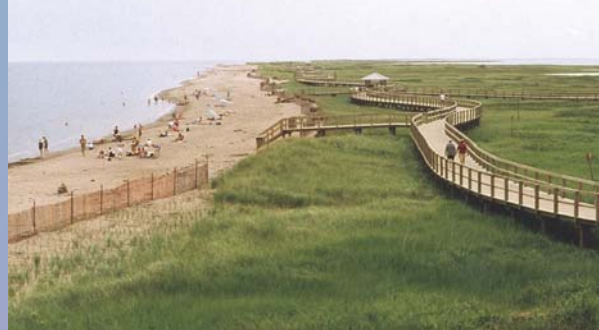
3. La Dune de Bouctouche - 1999, N.B.

At La Dune de Bouctouche, recent storms have resulted in considerable shoreline erosion, over-wash of the dunes and significant damage to the boardwalks. Portions of the dune are currently eroding at rates as high as 0.7 m per year and the northern end of the beach has experienced rapid landward migration, with the sand being replaced by cobble.

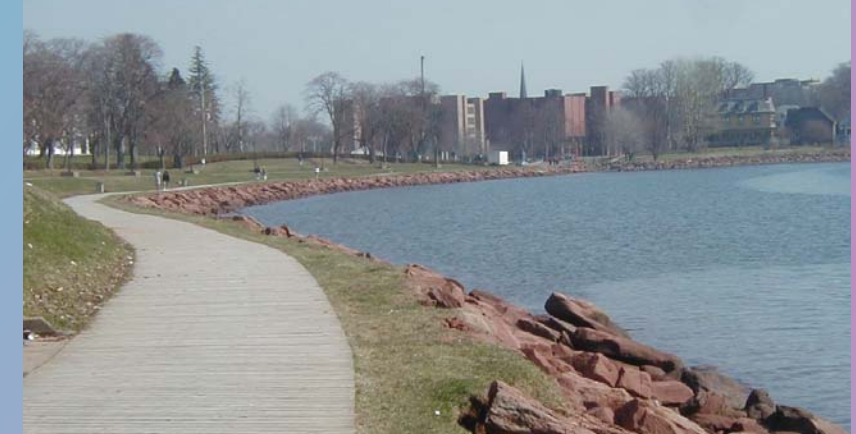
7. Charlottetown, P.E.I.

Unfortunately, like many other waterfront areas, these structures are susceptible to flooding and sea ice forced shoreward, which result in significant damage to boardwalks, pilings, and piers. In September 2003, the storm surge and waves from Hurricane Juan severely damaged the waterfront in Charlottetown and caused major erosion and undermining of the shoreline, torn geotextile, and damage to the boardwalk surface and structures. An increase in the occurrence and intensity of storm surges will put urban waterfront boardwalks at risk to more frequent flooding, as well as increased erosion. Relative sea-level rise and the increase in sea-level associated with climate change will also mean smaller storm surges will have a larger impact.

To address the present damage and future concerns about climate change in Charlottetown, several design options were considered, including a new concrete seawall, gabion basket seawall, 'native' sandstone riprap shore protection, and 'imported' quarried rock shore protection. In the end, significant effort was placed into locating a more resistant rock that would be aesthetically consistent with the red sandstone commonly found on Prince Edward Island.

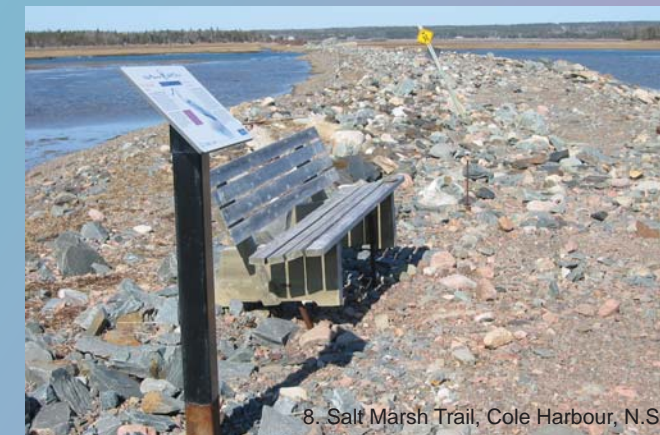
8. Salt Marsh Trail, Cole Harbour, N.S.

The Cole Harbour Salt Marsh Trail, located near Dartmouth, Nova Scotia was built on an abandoned section of the old Canadian National (CN) Upper Musquodoboit Railway. Historically, the harbour was dyked and the local salt marshes converted into cropland, but when the dyke was removed, tides flooded back and the area was allowed to revert back to marsh. This marsh provides important habitat for many songbirds, waterfowl and other forms of terrestrial and aquatic wildlife.

Because of increased frequency of strong winter storms, with high winds, waves and associated storm surge, the trail has been overtopped on several occasions during the past few years. With the arrival of Hurricane Juan in September 2003, the trail was reduced to rubble, with spots eroded down to the original rail bed. Along several portions of the trail the elevation was reduced to water level. The repair work has been extensive and included cleaning fallen and damaged trees, repairing the bridges, rebuilding the trail surface, and re-installing benches, interpretative panels and information kiosks.
